PTPD REPORT NO. 77-27
AFPEA REPORT NO. 76-P7-59

TEST AND EVALUATION OF CASKET FOR HUMAN
REMAINS INTENDED TO PROVIDE GUIDANCE
FOR SPECIFICATION IMPROVEMENT

AFALD/PTP
AIR FORCE PACKAGING EVALUATION AGENCY
Wright-Patterson AFB OH 45433

June 1977

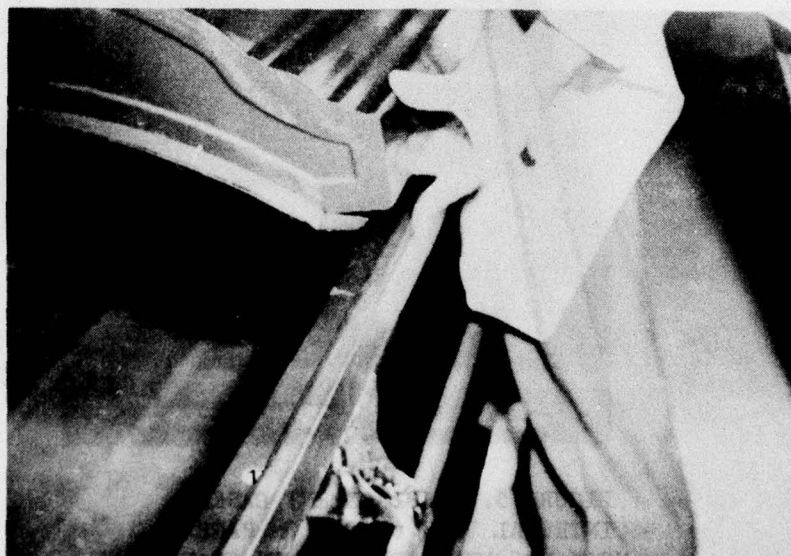
1. The bridge gasket is severely creased at both ends of the bridge (see Figure 7).

2. The lids make contact at their interface when opened (see scratches in Figure 7).

From these observations, it is concluded that the casket has the highest probability of leakage at both ends of the bridge due to the severe creases in the gasket.

FIGURE 7. CLOSE-UP OF ARCHED LID AND BRIDGE.
NOTE SEVERE CREASING AT THE BEND; ALSO,
SCRATCHES ON LID WHERE SURFACES MAKE CONTACT.

3. Specify the bridge between the lids be flat instead of arched (see Figure 6). This would prevent unnecessary bending and creasing of the bridge gasket at the ends.

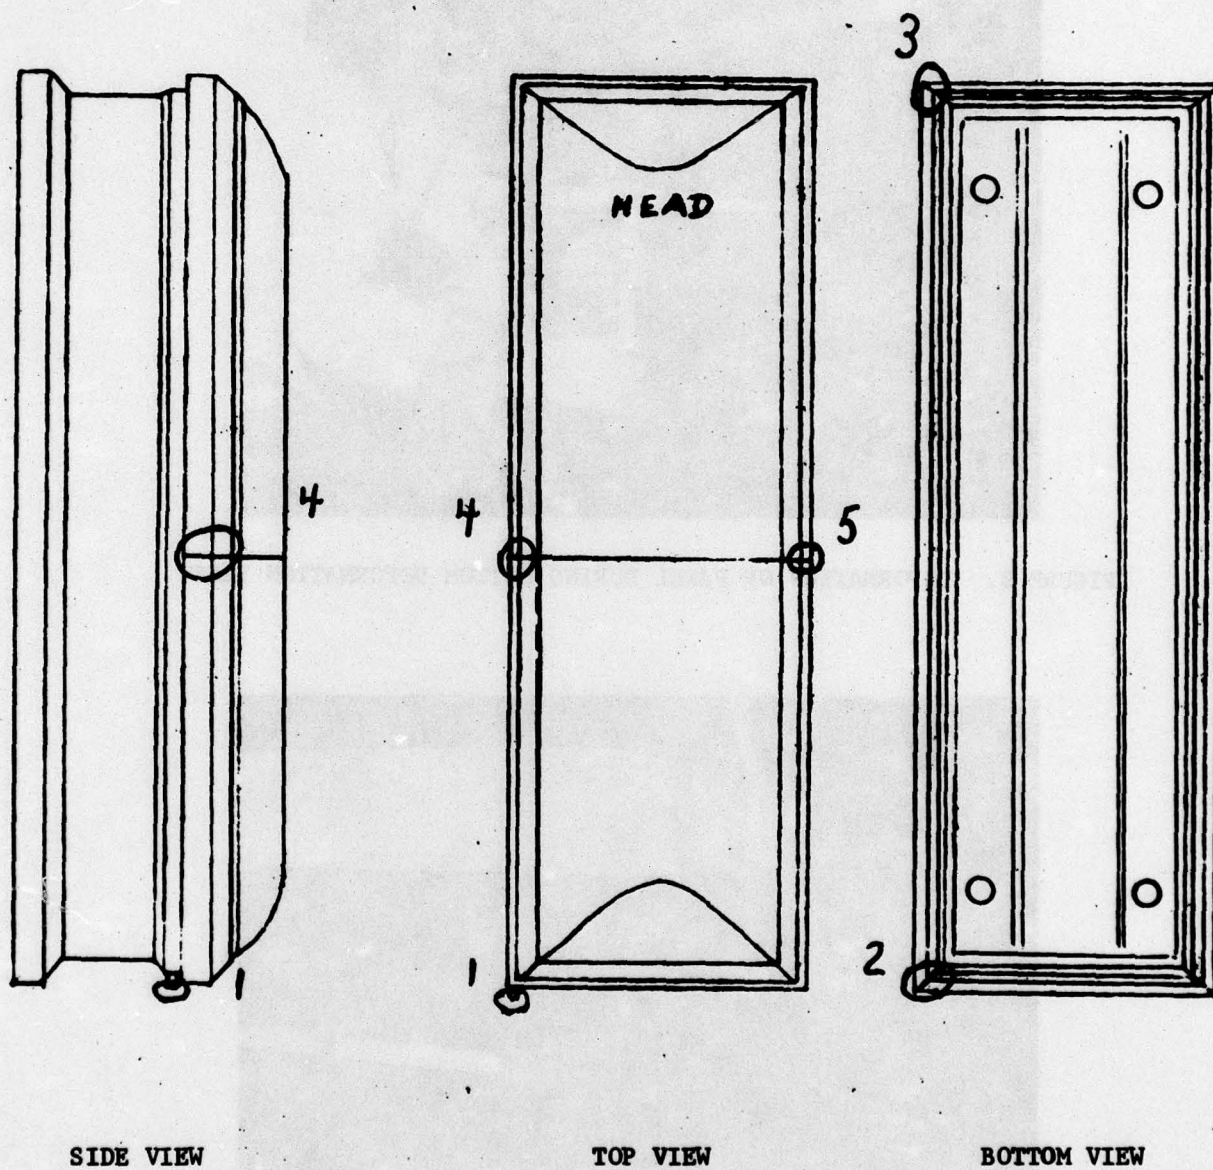
RESULTS: The test results indicated the presence of five leaks. Figure 8 illustrates their locations on the casket. The leak through the cap on the latching mechanism was very small although the gasket inside the cap makes no contact with the metal. Two leaks occurred in the bottom panel, both through the welds at the corners of the casket. The remaining two leaks were detected at both ends of the bridge between the two lids.

RESULTS: Those leaks found in the initial airtightness test results were still present during the final airtightness test. In addition, the casket leaked from the crack on the edge which was created by the impact test. The bottom panel indicated no evidence of leakage along any of the seams.

FIGURE 8. LEAKS FOUND DURING INITIAL AIRTIGHTNESS TEST

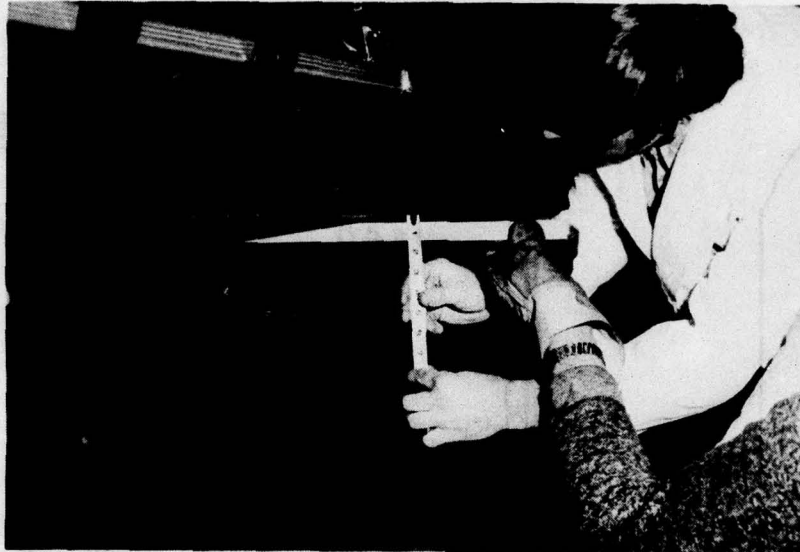
RESULTS: There was very little visual evidence of the bottom panel deformation. Logically, the greatest area of deformation occurred in the center of the bottom panel and by using a straight edge, evidence of this deformation was photographed and is displayed in Figure 9. The present specification requires the bottom panel to withstand a 350 pound load without deformation and in this respect the casket would not meet this requirement. However, visually the casket appeared to perform quite adequately.

FIGURE 9. DEFORMATION OF PANEL DURING BOTTOM DEFORMATION TEST

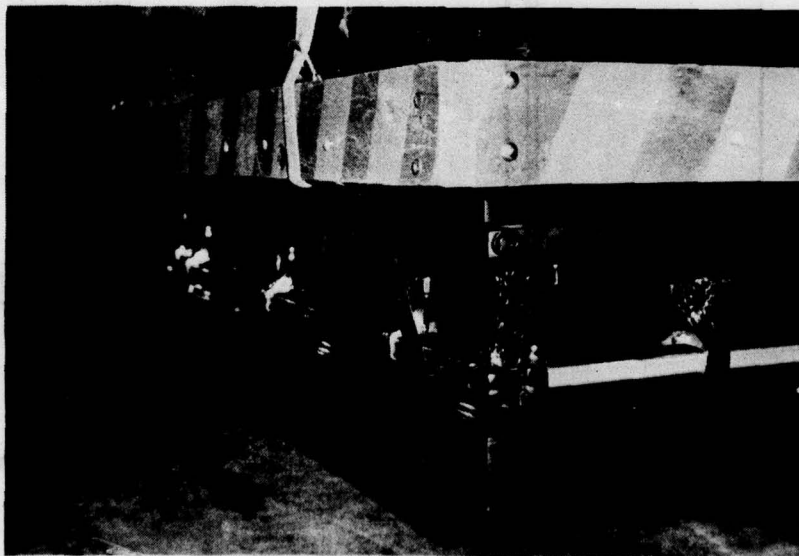
RESULTS: Test results indicate the handles show no signs of deformation (see Figure 10).

FIGURE 10. HANDLE BEND TEST

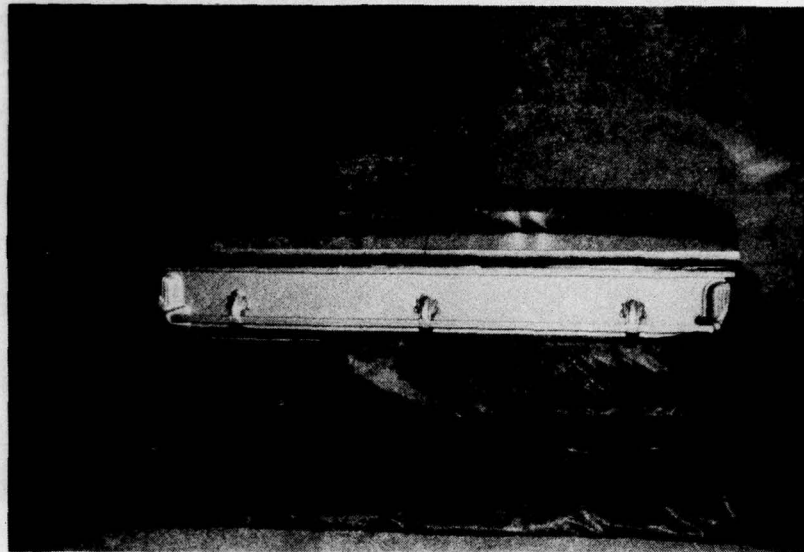
In the comparison with the 20 gauge casket (see Figure 11), the 18 gauge casket resisted the impact with very little damage. On the other hand, the 20 gauge casket experienced serious damage in several areas. Visual observations of the 20 gauge casket indicated

FIGURE 11. TWENTY GAUGE CASKET IN PADDED CANVAS OVERPACK

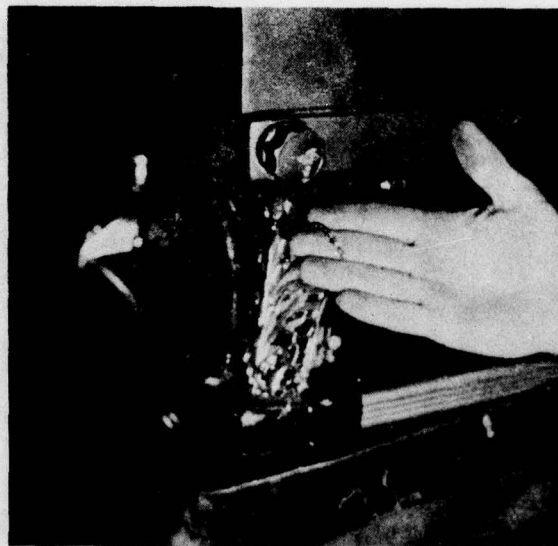
FIGURE 14. BROKEN CHAIN TO CAP CAUSED BY IMPACT

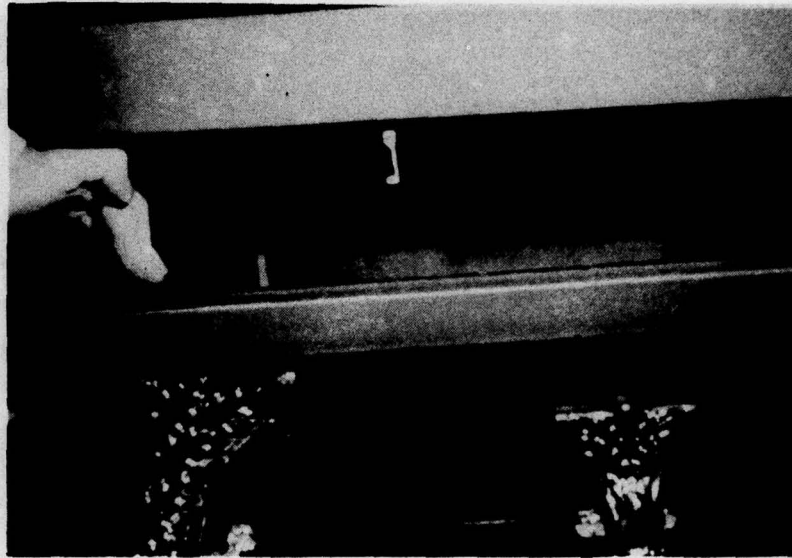
FIGURE 15. SLIGHTLY BENT LATCH DAMAGED FROM IMPACT

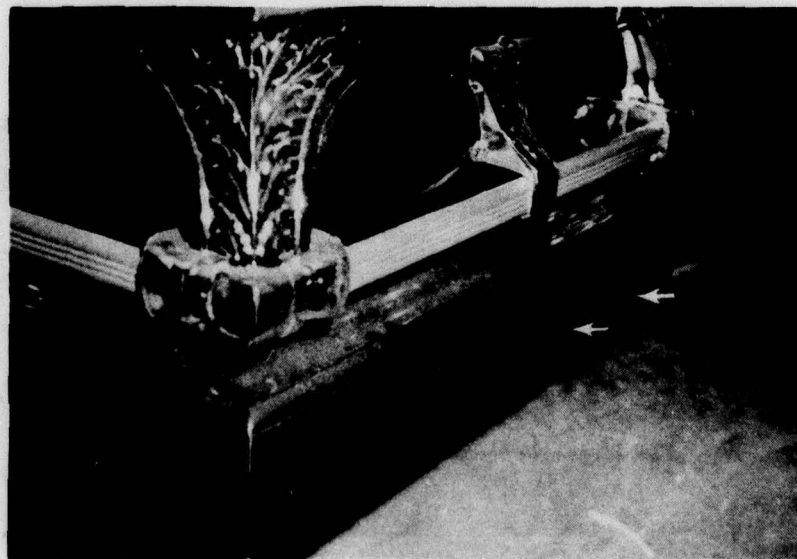
RESULTS: The casket was damaged slightly around the bottom frame at the head end. The effect was a small indentation or crease as shown in Figure 16 although almost undistinguishable. Another corner was separated and left a very small crack directly on the edge. The cap at the end of the latching mechanism was separated from its connecting chain (see Figure 14). This cap protrudes from the casket receiving much of the initial impact. This, in turn, caused the force to be transmitted through the entire latching mechanism slightly bending the latches (see Figure 15). Even though the rotation of the crank was found to be more difficult, the latching mechanism was still functional and acceptable.

FIGURE 16. SLIGHT DAMAGE FROM IMPACT TO EIGHTEEN GAUGE CASKET

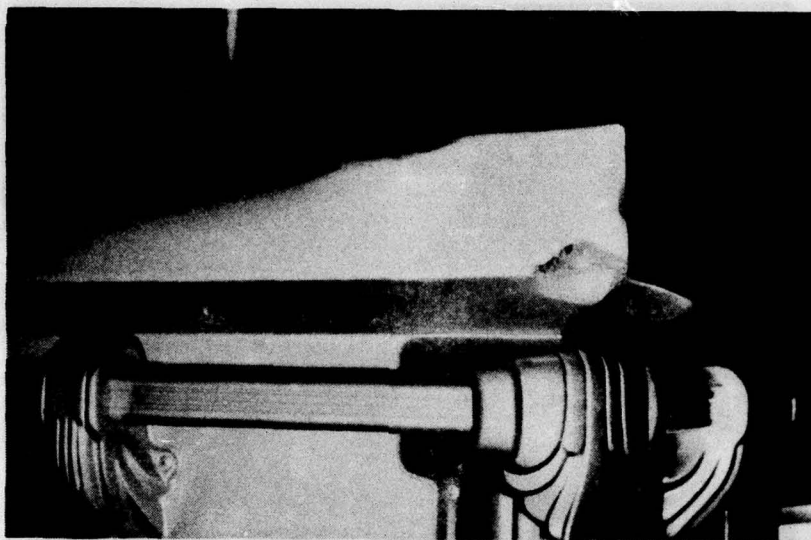
many large indentations (see Figures 17 and 18) and separation of the cover from the latching mechanism (see Figure 19). The affect of the impact on the bottom panel seal of the 18 gauge casket was tested in the final airtightness test.

FIGURE 17. MAJOR DAMAGE TO TWENTY GAUGE CASKET
IN PADDED OVERPACK. DAMAGE IS DUE TO IMPACT.

4. Specify the use of 18 gauge metal for construction of the casket due to its superior resistance to rough handling.

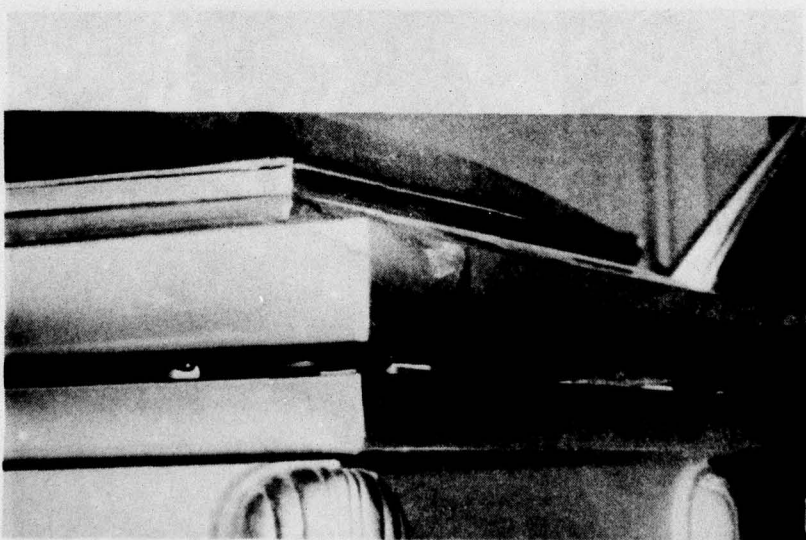
FIGURE 18. DAMAGE TO TWENTY GAUGE
CASKET LID AS A RESULT OF IMPACT

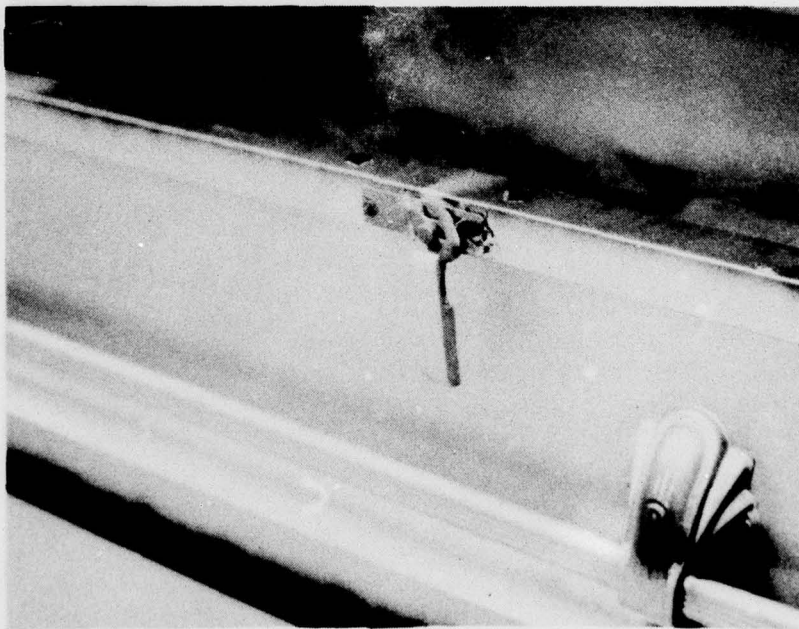
**FIGURE 19. BROKEN LATCH COVER DUE TO IMPACT TO
TWENTY GAUGE CASSET IN PADDED CANVAS OVERPACK.**
